This is the final investigation report of the Dec. 12, 2023, bus crash on the UC Santa Cruz campus. Please note that redactions were made to remove the personally-identifying information of witnesses, except the names of those who were acting in their capacity as UC Santa Cruz employees and the decedent. Redactions were also made to remove the witnesses' and decedent's personal information while preserving the relevant conclusions derived from that information.

UC SANTA CRUZ POLICE DEPARTMENT, FOR OFFICIAL USE ONLY

**MAIT SUPPLEMENTAL**

This investigation was conducted by the California Highway Patrol (CHP) Coastal Division Multidisciplinary Accident Investigation Team (MAIT).

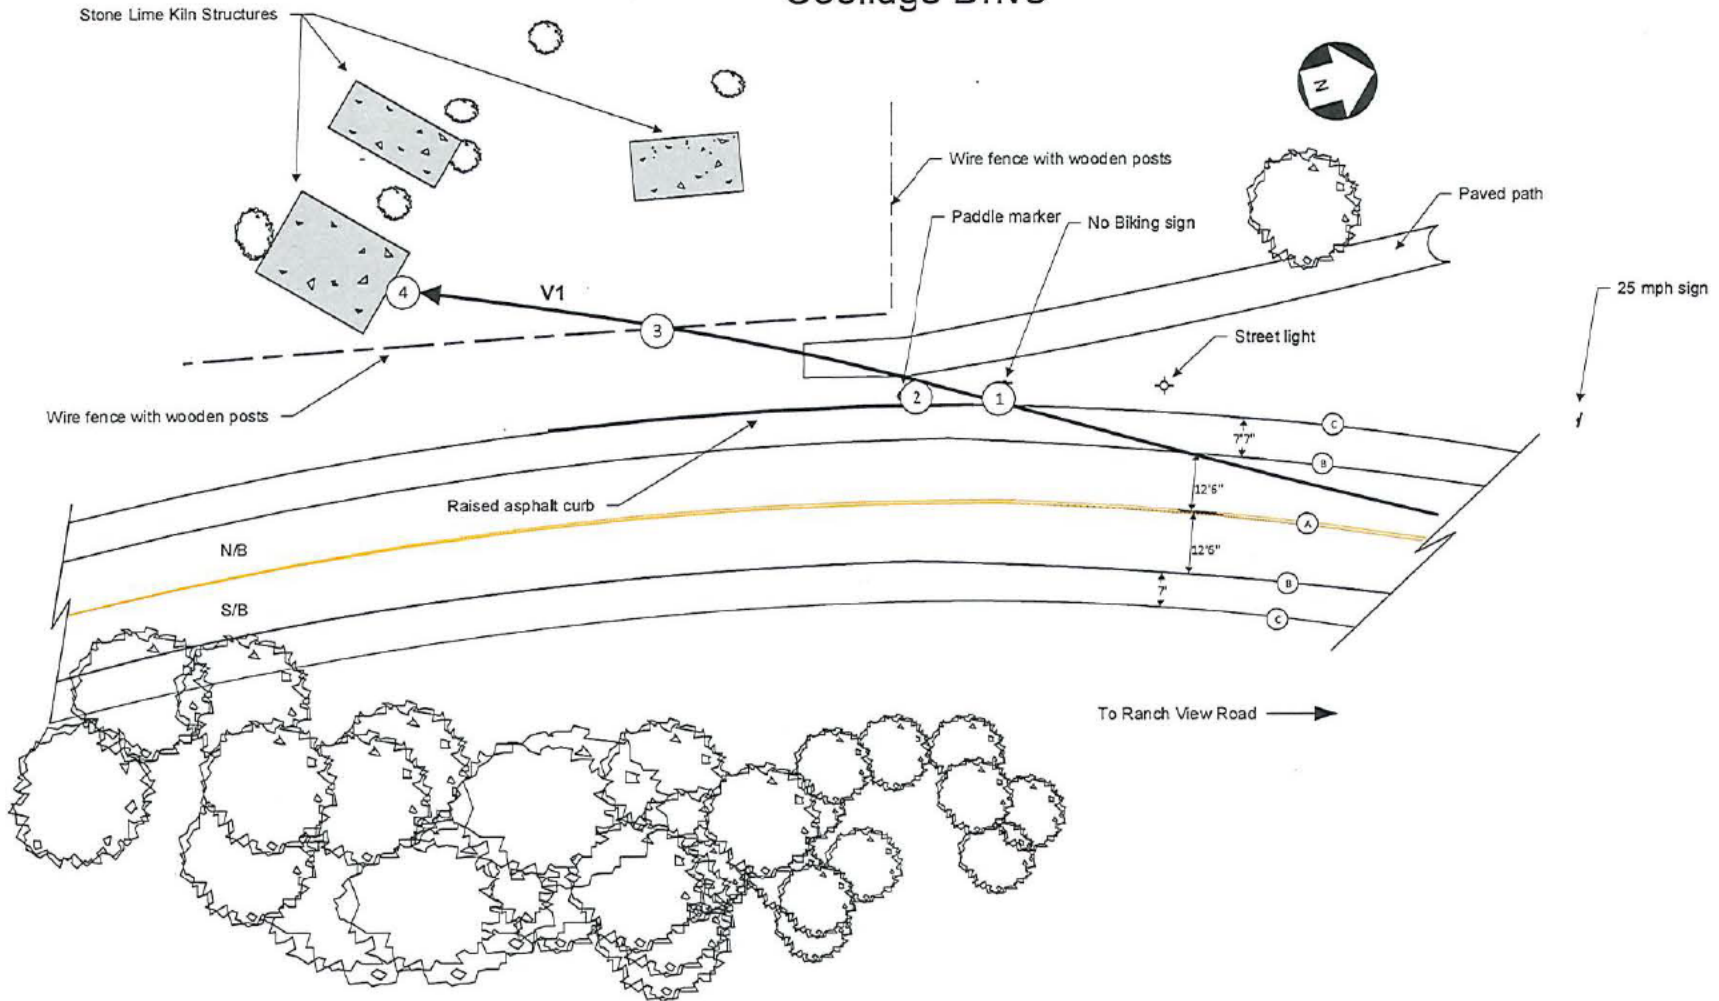
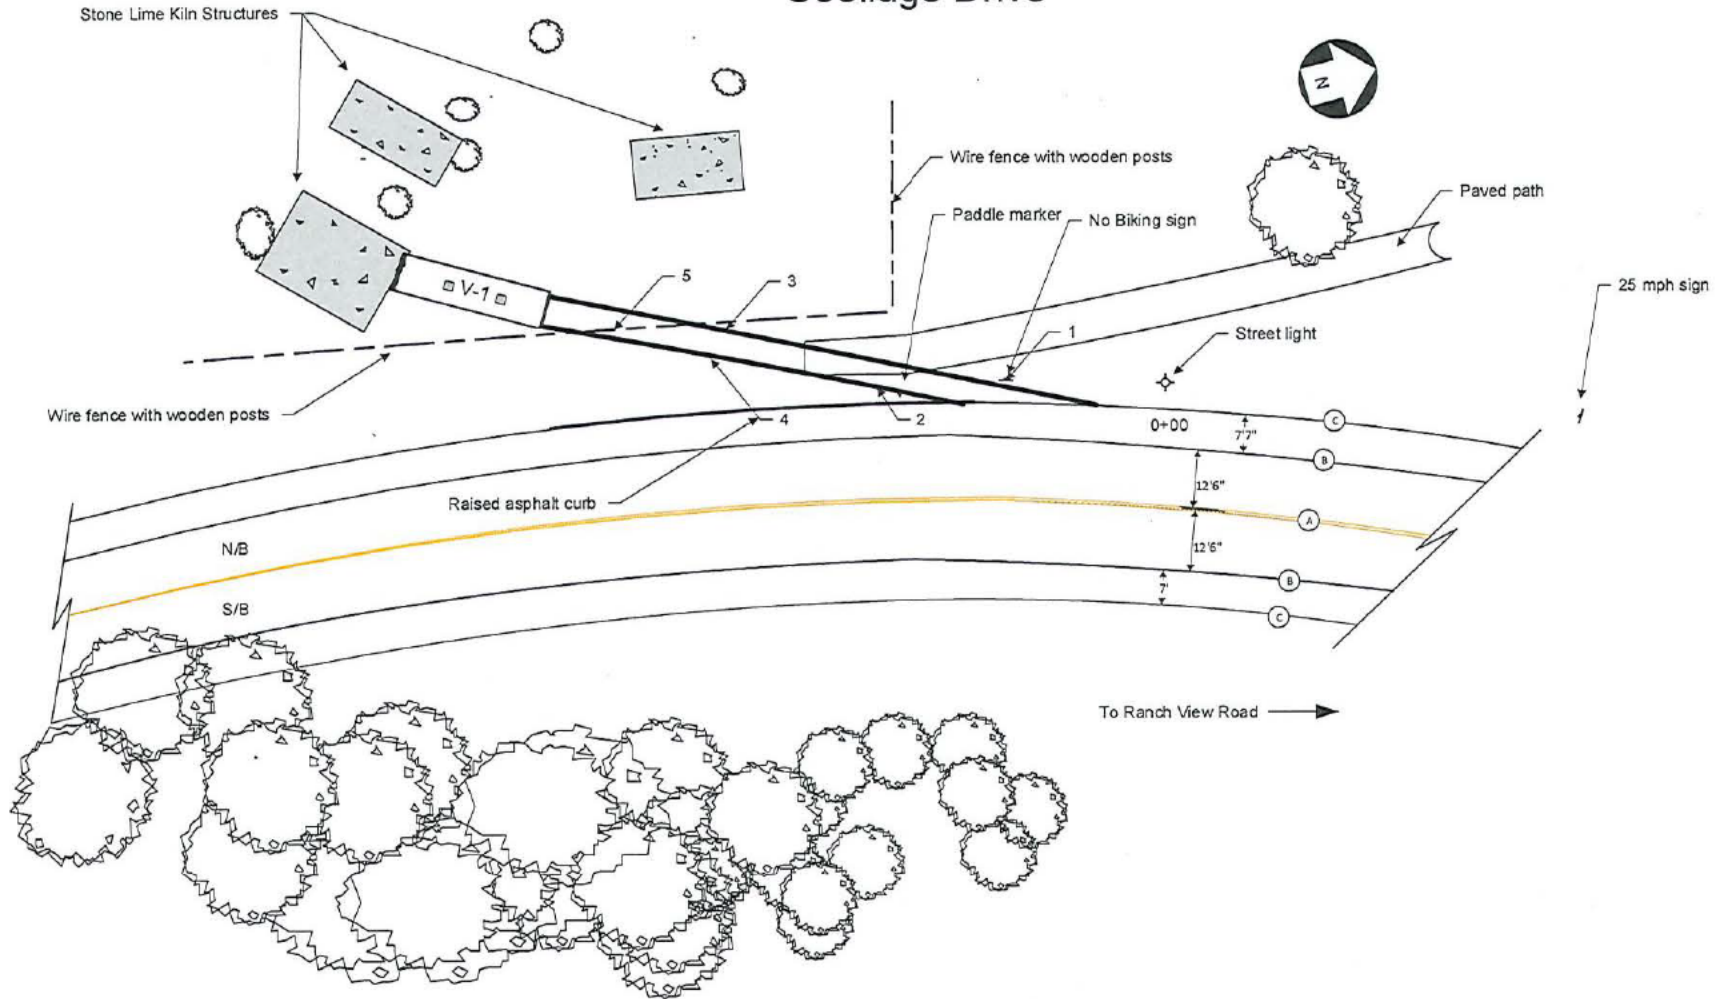
On December 12, 2023, at approximately 2030 hours, D-1 was driving V-1 southbound on Coolidge Drive in a downhill, sweeping, left hand turn south of Ranch View Road while transporting five (5) UCSC students. For an unknown reason, D-1 failed to provide sufficient steering input or braking and allowed V-1 to exit the west roadway edge of Coolidge Drive. V-1 then struck a metal sign, paddle marker, metal/wood fence, and stone wall (lime kiln) before coming to rest.

The areas of impact were determined by witness statements, physical evidence, damage to V-1.

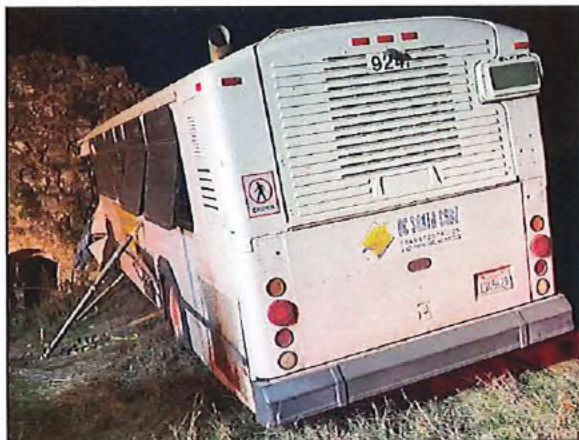
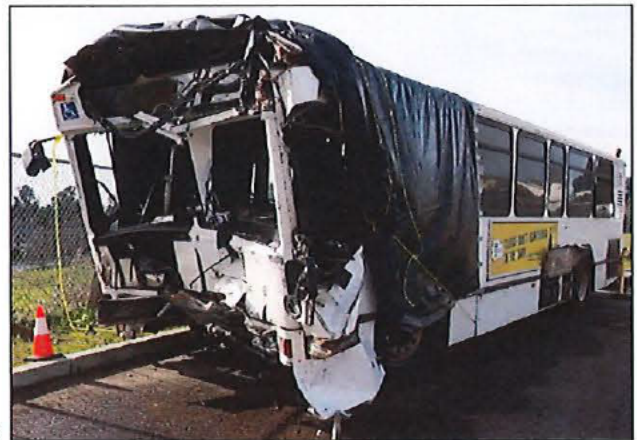
Figure 1. A—Vehicle 1 at its position of rest at the collision scene B—Overview of Vehicle 1 from left-front corner at UCSC PD ERC

The mechanical inspection and testing performed on this vehicle—including throttle operation, power train, tires and wheels, steering, suspension, and the air brake system—did not reveal any evidence of pre-existing mechanical conditions or failures that would have contributed to the cause of this crash. The described damage to these systems was a result of collision forces during the crash.
